On July 17, 2017 Lycoming published Mandatory Service Bulletin 632 - Identification of Connecting Rods with Non-Conforming Small End Bushings. The current revision is 632 Revision B and the FAA has issued Airworthiness Directive 2017-16-11. The Service Bulletin is available on the Lycoming website at <a href="https://www.lycoming.com">www.lycoming.com</a>.

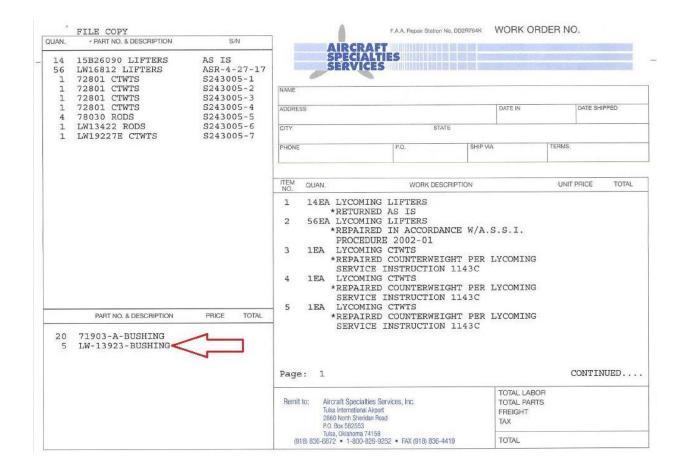
To determine if a Connecting Rod repaired by Aircraft Specialties Services, Inc. is affected by Mandatory Service Bulletin 632, please refer to the invoice that was sent with the Connecting Rod. In the lower left corner of the invoice is a "Part Number and Description" box. If the invoice is dated from August 1, 2016 to July 17, 2017 and part number LW-13923 is listed, Mandatory Service Bulletin 632B may apply based on the limited information provided by Lycoming.
